Manhole Inspection Summary

Manhole # S63A__011MH

Inspection ☐ Is Incomplete Rating: **3) Fair**

Insp Date: **3/9/10 11:02 AM**

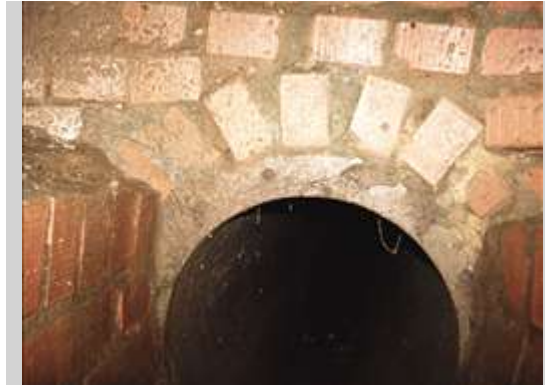
12 O'Clock Outflow
Pipe Out @ 12 O'Clock

Drop: **None**

Pipe Height: **19.2** (in.) Rod and Bar (Angled)
Pipe Material: **Clay** ☐ Pipe Lined
Invert Depth: **17.58** (ft.) Flow Characteristics: **Slow**
Deposits: ☒ None ☐ Mud ☐ Sludge ☐ Debris ☐ Grease
Silt Depth: (in.) Deposits Extent:
Infiltration: **None** Pipe Seal Cond: **Sound**
